Gabions, A Poor Design for Shore Hardening: The Puerto Rico Experience

C. W. Jackson[†]; D. M. Bush[‡] and W. J. Neal[∞]

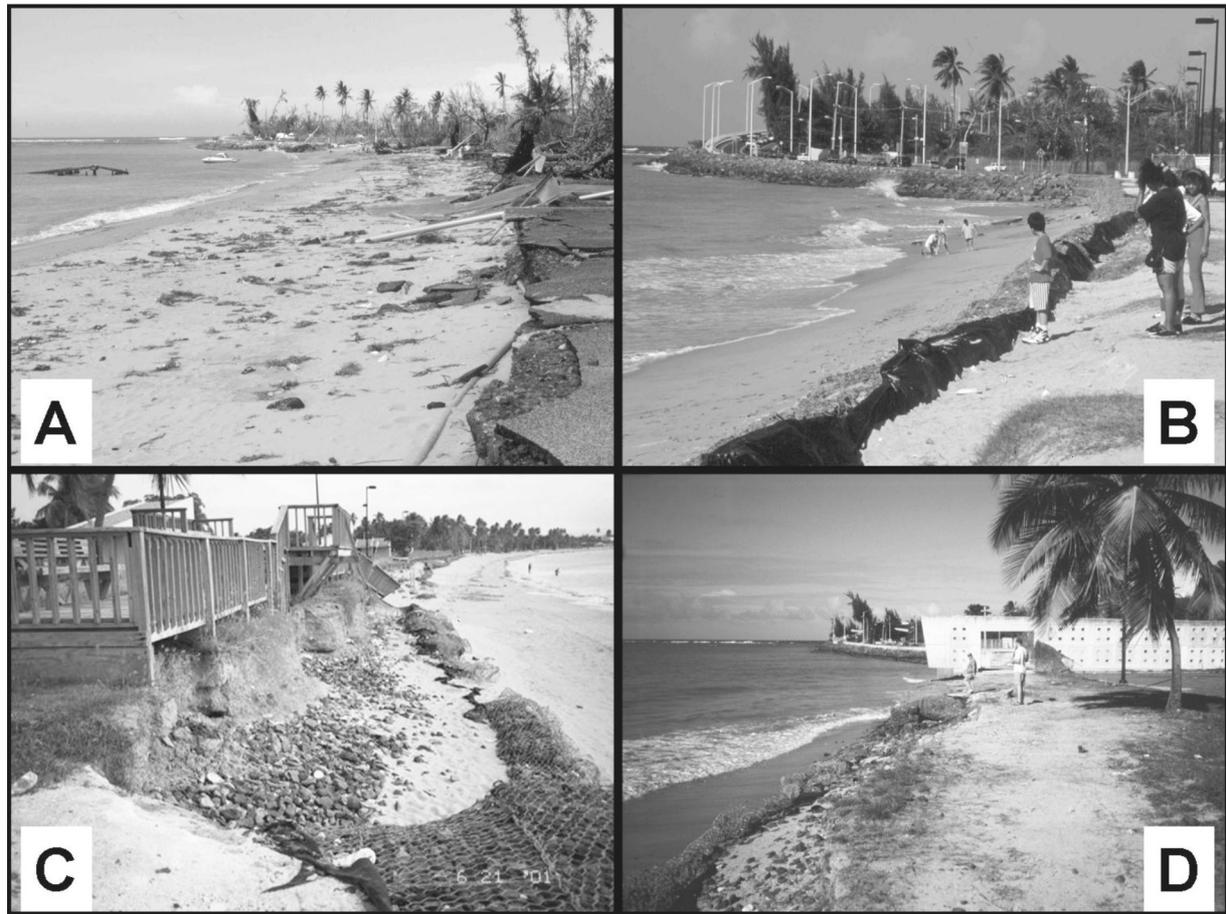
Balnearios are public swimming beaches maintained by local governments. Balneario de Carolina (Figure 2; previously named Balneario de Isla Verde) is certainly the most popular and heavily used public beach in the San Juan metropolitan area. The shoreline here has been experiencing erosion for many years. Note the remnants of a beach boat launch just offshore in Figure 2-A. Swell from a January, 1988, North Atlantic winter storm formed an approximately 1-meter high erosion scarp (Figure 2-A). The passage of Hurricane Hugo in September 1989 caused further erosion. To combat the persistent erosion problem, a gabion wall was emplaced soon thereafter.

By 1994, a gabion had been built and already begun to deteriorate (Figure 2-B). Filter cloth had been used behind the gabion to prevent washout of sediment by downward water movement, but it seemed to have little positive effect. The gabion began to fail almost immediately by undermining and piping, eventually collapsing onto the recreational beach (Figure 2-B). Continued erosion along with deterioration of the gabions has led to several generations of modifications and repairs to the gabions. Ultimately the gabions have failed, spilling rock and wire debris onto the recreational beach.

Figure 2. Balneario de Carolina (previously known as Balneario de Isla Verde). Balnearios are public swimming beaches with amenities and maintained by a local government. Major erosion caused by swell from a January, 1988, winter storm, and the passage of Hurricane Hugo in September, 1989, resulted in the emplacement of gabions. Continued erosion along with deterioration of the gabions has led to several generations of modifications and repairs to the gabions. Ultimately the gabions have failed, spilling rock and wire debris onto the recreational beach. (a) Immediately after the January, 1988, winter storm swell erosion. View to the east. The boat ramp marks the shoreline previous to the mid-1970's. (b) Similar view as (a), but in 1994 after gabion has been built and begun to deteriorate. Note filter cloth behind gabion. (c) A wooden observation deck was added and threatened by erosion by 2001. View to the west. (d) Major monument structure built on the retreating shoreline and already deteriorating by January 2002. View to east.

By 2001 (Figure 2-C), a wooden observation deck had been built and threatened by erosion. The gabion was almost completely destroyed and was not protecting the platform, but was creating hazards for beach users. Not content in realizing this as a high-hazard erosion area, more coastal "improvements" were made in the form of a concrete and steel monument structure built right on the shoreline, seen in this January, 2002, photo (Figure 2-D). Notice the deteriorated gabion collapsing and leaking rocks onto a narrowing beach. Also, the monument had sand and loose rock washed up onto it, and was rusting noticeably.

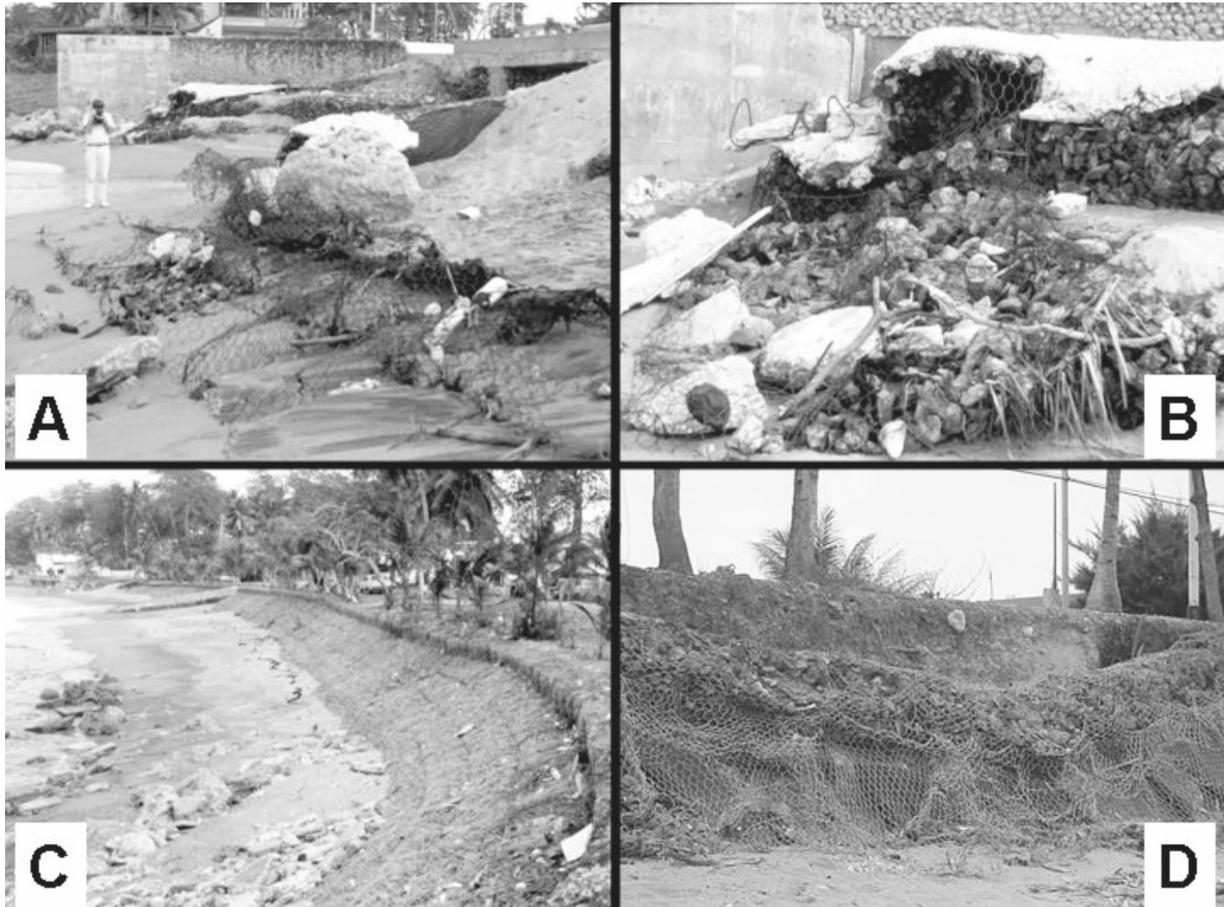
Even though it may seem much calmer on any typical summer day, the west coast of Puerto Rico can experience the largest waves to impact the island in the form of far-traveled swell from major North Atlantic winter storms. A gabion was built in the late 1980s along part of the Aguada shoreline, near the Parque de Colón (Figure 3). By 1992, the wall was already deteriorating. The steel-wire mesh has ruptured and the stone fill dispersed by waves (Figure 3-A). Rusting wire and stones litter the beach creating a hazard to beach users. Ultimately a cement covering was added an unsightly attempt to hold the wall together (Figure 3-B). This material was eventually undercut by storm waves, creating an even bigger mess on the beach. Further south, just down the beach from Parque de Colón, a long stretch of gabion limits access to the beach from

the moderate-elevation bluff (Figure 3-C). By 2000, much of this stretch of gabion was failing (Figure 3-D). The sloping Aguada gabion wall also is a debris catcher, littered with driftwood and flotsam, further detracting from beach aesthetics.

Figure 3. Gabion wall near Aguada's Parque de Colon, built in the late 1980s. (a) and (b) By 1992 the wall had already deteriorated and been "improved" with a concrete covering, which in turn had been broken by storm wave action. Fill rock from the failed gabion was observed to be washed several tens of meters up into the small drainageway visible in (a). (c) Just to the south the entire bluff was covered with a sloping gabion, visible in this 1992 photograph. Note that the wire mesh traps driftwood and flotsam. (d) By summer of 2000, the gabion in (c) was severely compromised.

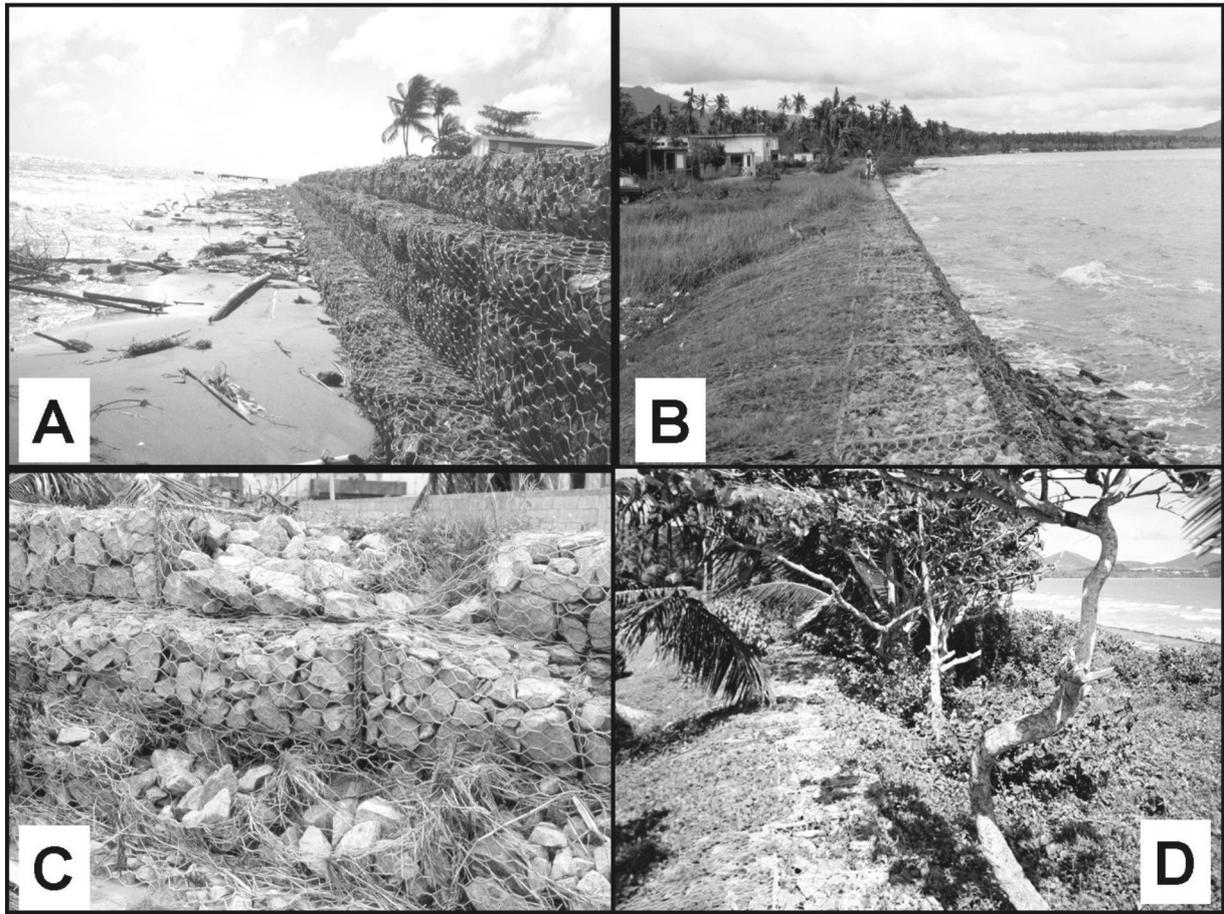
On the east coast, at the northern end of Playa de Humacao and a few blocks north of a small pier, there is a gabion wall, approximately 2 meters high, with a stepped vertical front and a gently sloping rear (Figure 4). The gabion was a response to coastal erosion and property damage caused by the passage of Hurricane David in 1979. Built about 1983 at a cost of over \$200,000, the gabion is over 100 meters long and extends north to the small river, Río Antón Ruíz. In 1988, the wall was basically intact, but showing signs of deterioration (Figure 4-A). The passage of Hurricane Hugo in 1989 did not severely damage the wall, but highlighted some spots of previous deterioration, spilling some fill rocks onto a narrowed beach (Figure 4-B). By 1991, several of the wire cages were failing and fill rocks were spilling out onto the beach (Figure 4-C). By January, 2002, the gabion wall was still standing without major deterioration (Figure 4-D). It was overgrown with small trees and spot failures had not been repaired.

Sediment input from the Río Antón Ruíz helps maintain this shoreline stretch, and it is questionable that any stabilization structure was needed here. Although this beach is not used a great deal for swimming, the continued gabion deterioration

and leaking rocks have degraded the beach.

Figure 4. After erosion caused by Hurricane David in 1979, a gabion was emplaced along a 100-meter stretch of the Playa de Humacao shoreline just south of Rio Anton Ruiz. (a) Only a few years old in 1988, the wall was already beginning to show signs of deterioration. (b) Hurricane Hugo (1989) did not cause major damage to the wall, but narrowed the beach for a short time. Some rocks were spilling onto the beach. (c) By 1991 the wall was failing in several places. (d) The gabion wall was allowed to become overgrown by 2002, and was not being maintained.

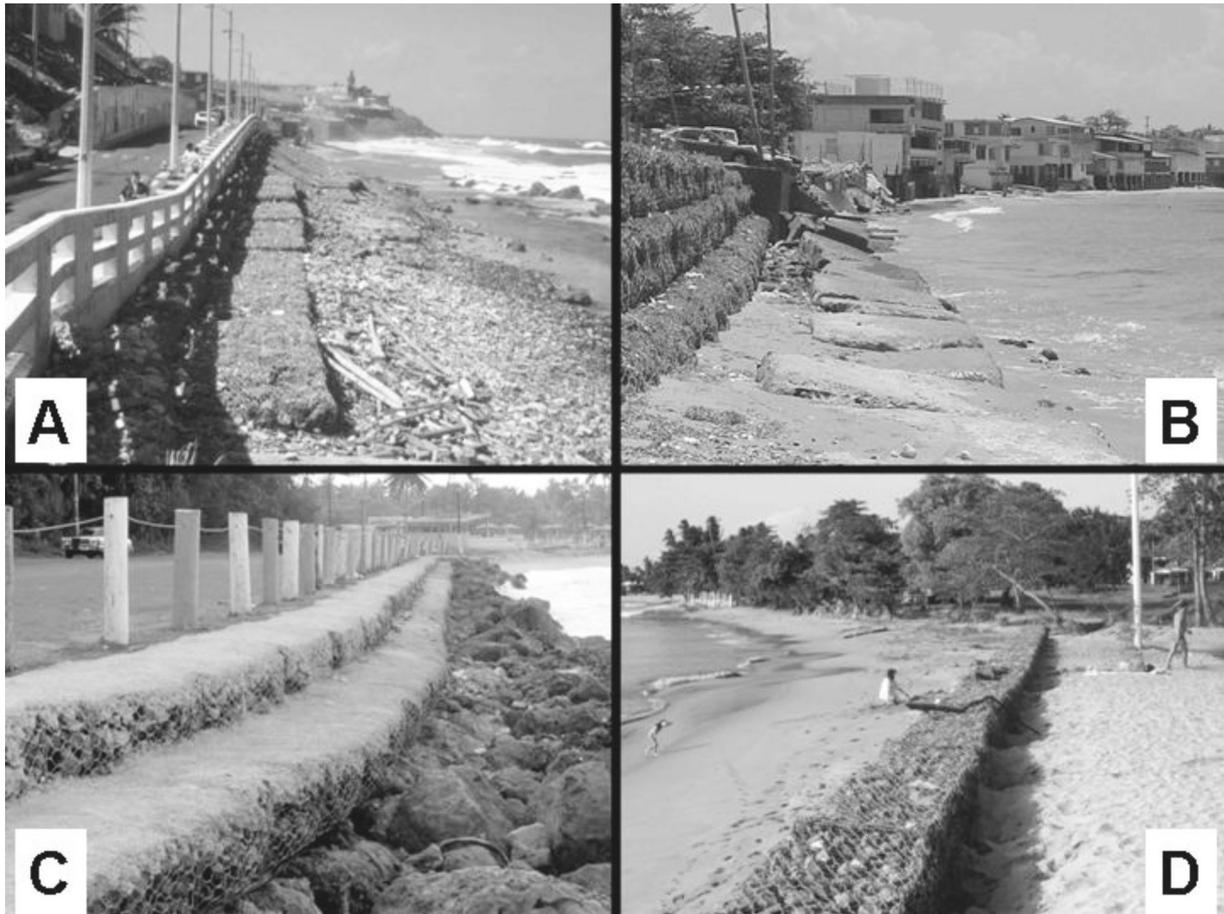
Even without a time-series of photographs, several examples of gabions as a poor design choice for shoreline stabilization are evident around the coast of Puerto Rico. For example, in the La Perla urbanization of Old San Juan, a gabion "protects" a road running along the coast and facing directly into the North Atlantic Ocean (Figure 5-A). The hillside is Pleistocene eolianite, so a solid rock wall to protect the road would have more closely matched the natural setting. Another candidate for future replacements is the multi-tiered gabion that faces into the high-energy North Atlantic Ocean near Puerto Nuevo on the north coast about 30 km west of San Juan (Figure 5-B). The gabion had only recently been emplaced when the photo was taken in summer, 2000. Near the northern corner of the west coast, just northeast of the mouth of Río Guayabo, a gabion was emplaced to protect the road. When visited in 1992, the gabion was failing by piping and undercutting, and modified by covering with a concrete cap and installation of a riprap wall in front of the gabion (Figure 5-C). In the end, the low-cost engineering approach ultimately led to costly continued maintenance and improvements, resulting in a more expensive structure. A better approach would have been to either build a better-designed seawall in the first place, or avoidance of the problem if possible by relocating the road. Further south on the west coast, Balneario de Rincón is an example of a "wall for no reason" (Figure 5-D). Recall that balnearios are public swimming beaches, so there should be nothing to "protect." The gabion (shown in a 1992 photo) merely adds a structure,

dividing the recreational beach, and limiting access to the ocean. By 2002, the gabion had been replaced by a solid concrete wall. Balneario de Carolina (Figure 2) is another example of a wall with no reason, on a public swimming beach with nothing to protect.

Figure 5. Gabion Miscellany. (a) La Perla urbanization of Old San Juan, view to west, January, 1988. (b) Near Puerto Nuevo on the north coast, summer 2000; the endpoint of an urbanized shore. (c) Near Rio Guayabo, on the west coast of Puerto Rico, in 1992. (d) A “wall for no reason” at Balneario Rincon, on the west coast of Puerto Rico, in 1992. This structure was removed and replaced with a solid bulkhead wall sometime prior to 2002.
