## Processes and Patterns of Sedimentation at Blind Pass, Florida

TIDWELL, D.A. and WANG, P., 2006. Processes and patterns of sedimentation at Blind Pass, Florida. *Journal of Coastal Research*, SI 39 (Proceedings of the 8th International Coastal Symposium), 509 - 514. Itajaí, SC, Brazil, ISSN 0749-0208.

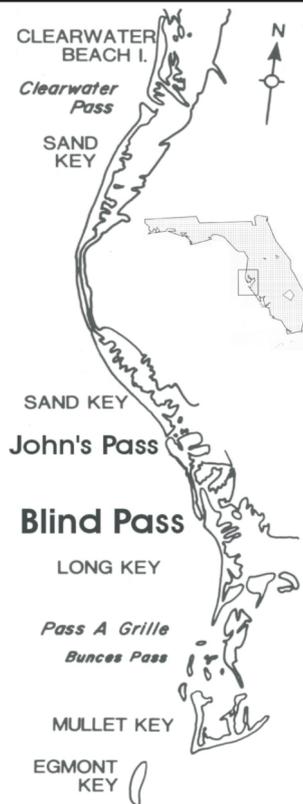
Figure 1. The study area. The water body landward of Blind Pass and John's Pass is the Boca Ciega Bay.

Blind Pass is located in the west-central Florida coast (Figure 1). It is a typical wave-dominated tidal inlet (DAVIS, 1997; DAVIS and HAYES, 1984) and has been migrating rapidly southward along shore, driven by the regional southward longshore sediment transport. The net rate of the southward longshore transport was estimated to be approximately 36,000 m<sup>3</sup> per year (WALTON, 1973; WANG *et al.*, 1998a, 1998b). The south jetty was constructed in 1937 to stop the southward migration. Before that time, Blind Pass migrated southward for over 3,000 m. Historical aerial photos indicate that the pass moved approximately 600 m between 1926 and 1937. The pass was further stabilized with a northern jetty in 1962. Both jetties have since been extended. Although the inlet position has been stabilized, the channel filling has been extremely active. The channel has been dredged 12 times since 1937. The sand dredged from Blind Pass has been used to nourish the updrift Treasure Island to the north and the downdrift Upham Beach to the south. A summary of the morphological history of Blind Pass is presented in TIDWELL *et al.* (2003).

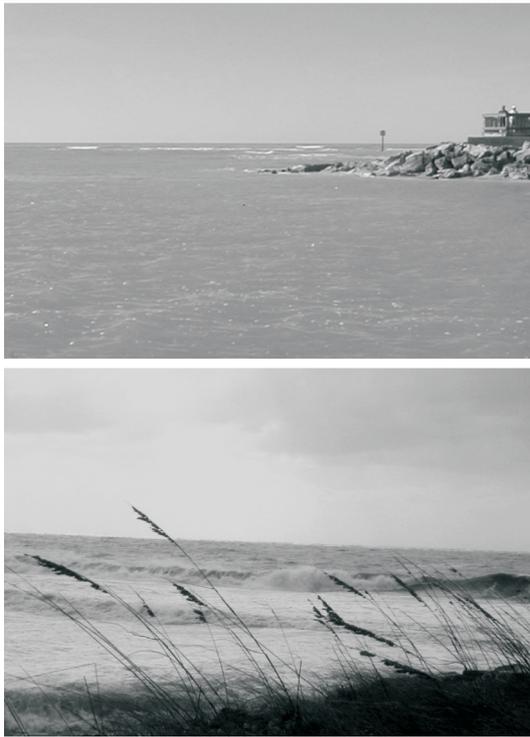
Figure 7. Active wave breaking over the northern shoal in the inlet channel. Upper: wave breaking during low tide; lower: wave breaking during a winter storm.

shallow. Substantial wave breaking occurs during low tide and during storm conditions (Figure 7). During February 2002, a considerable portion of the shoal became exposed during spring low tide. The active sediment suspension due to wave breaking at low tide and the relatively strong flood current over the northern shoal area (Figure 4A) may provide a mechanism for landward sediment transport. This mechanism is believed to be responsible for the erosion near the Gulf entrance and accumulation further in the channel measured during the summer season.
