## Assessment of a Gravel Nourishment Project Fronting a Seawall at Marina di Pisa, Italy

CAMMELLI, C.; JACKSON, N. L.; NORDSTROM, K. F. and PRANZINI, E., 2006. Assessment of a gravel nourishment project fronting a seawall at Marina di Pisa (Italy). *Journal of Coastal Research*, SI 39 (Proceedings of the 8th International Coastal Symposium), 770 - 775. Itajai, SC, Brazil, ISSN 0749-0208.

A gravel beach was created in winter 2001-2002 seaward of a 330-meter-long seawall at Marina di Pisa, Tuscany, Italy. A monitoring project was performed to evaluate the stability of the new beach and the interaction between the coarse fill and the fine sand comprising the nearshore profile. Bathymetric surveys were conducted in October 2001, before the nourishment operation, in March 2002, two weeks after nourishment, and in January 2003. Topographic surveys were conducted from the backshore to 9 m depth along eleven cross-shore transects spaced every 25 m. Sediment samples were collected on the nearshore surface prior to nourishment and on the nearshore and nourished beach following nourishment. One-meter-deep trenches were dug across the beach in May 2002 and January 2003. Shoreline planform a

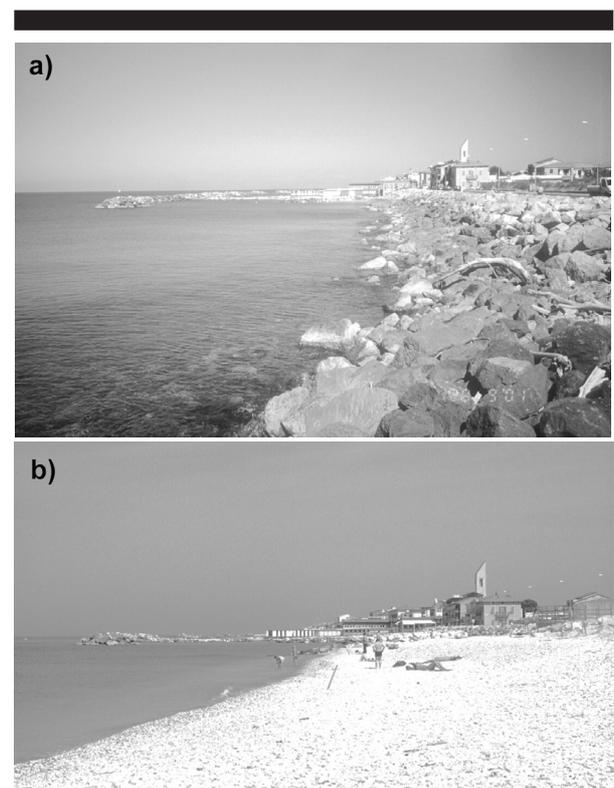
Figure 2. Study site looking north on September, 2001 prior to nourishment (a) and on May, 2002 following nourishment (b).

The experimental nourishment was carried out seaward of the southern part of the seawall, where no offshore structures are present and no beach existed prior to the project (Figure 2 a).

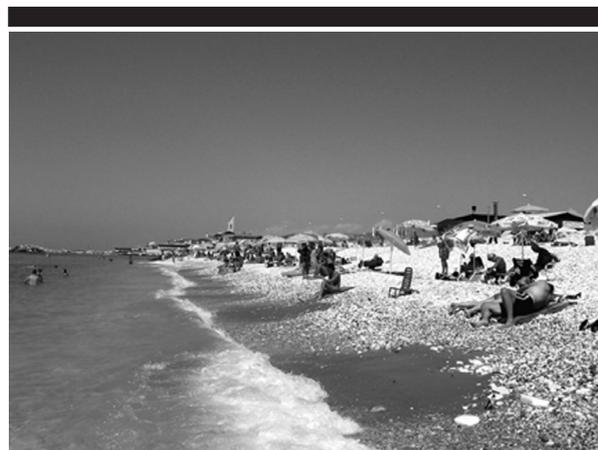
Figure 8. Recreational use of the beach at the fill site in summer of 2003.

Field observations of the beachface and data collected from trenches dug into the berm allow interpretation of sedimentological changes. As on other sand and gravel beaches (MASON and COATES, 2001), the nourished beach has its surface covered by coarse sizes, but patches of a few square meters of sand occur near the shoreline (Figure 8) or beneath the gravel layer.
